Executive Summary

Groundwater Resources Information Technologies Ltd. (GRIT) was retained by Allan Markin to complete a Level IV Private Sewage Treatment System (PSTS) assessment for a 13 – lot residential subdivision within SE – 21 – 24 – 3W5 in Rocky View County, Alberta (hereinafter referred to as the Site). The purpose of the investigation was to establish the soil texture and structure across the Site to establish the feasibility of future PSTS installations on the residential lots. A site map of the proposed development is provided in **Appendix A**.

Project: Markin Level IV PSTS

File No: 2021-1675

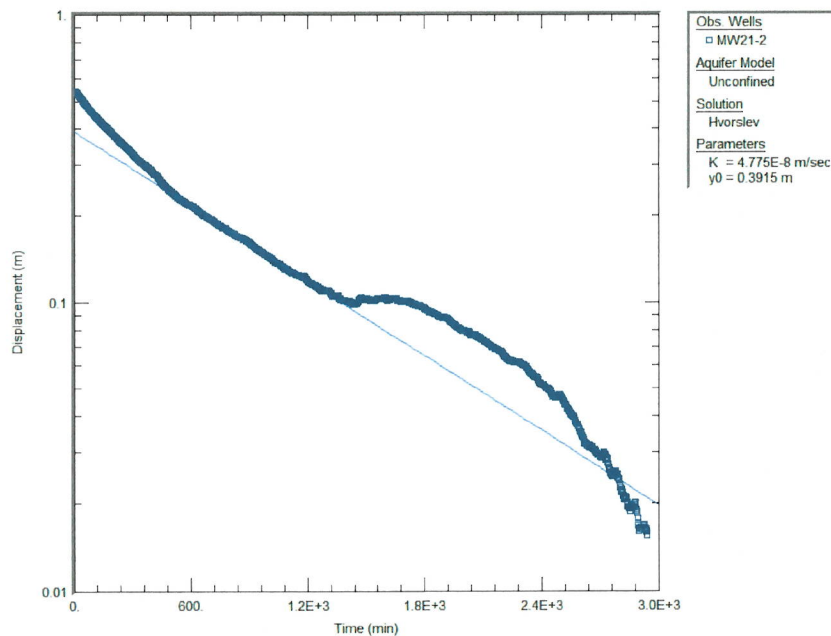
Figure 2. Hvorslev solution fit to slug test data from MW21-2

The hydraulic conductivity in MW21-2, completed within silty clay deposits, is 4.8×10^{-8} m/s. This is within the expected range for a silt clay deposits.

The slug test results from the two wells completed in silty clay deposits (MW21-2 and MW21-3) show very similar hydraulic conductivity values. The silty clay deposits they are completed in are likely part of the same geological unit which spreads across the site from near surface to approximately 14.0 meters deep. As the permeability of these units are so low they will act as an effective barrier between the septic field systems on surface and the underlying bedrock sandstone aquifer, located below 14.0 meters. According to Alberta Tier 2 Soil and Groundwater Remediation Guidelines (2019) a layer exceeding 5 meters in thickness with a permeability less than 10^{-7} m/s constitutes a barrier layer. The silty clay layer

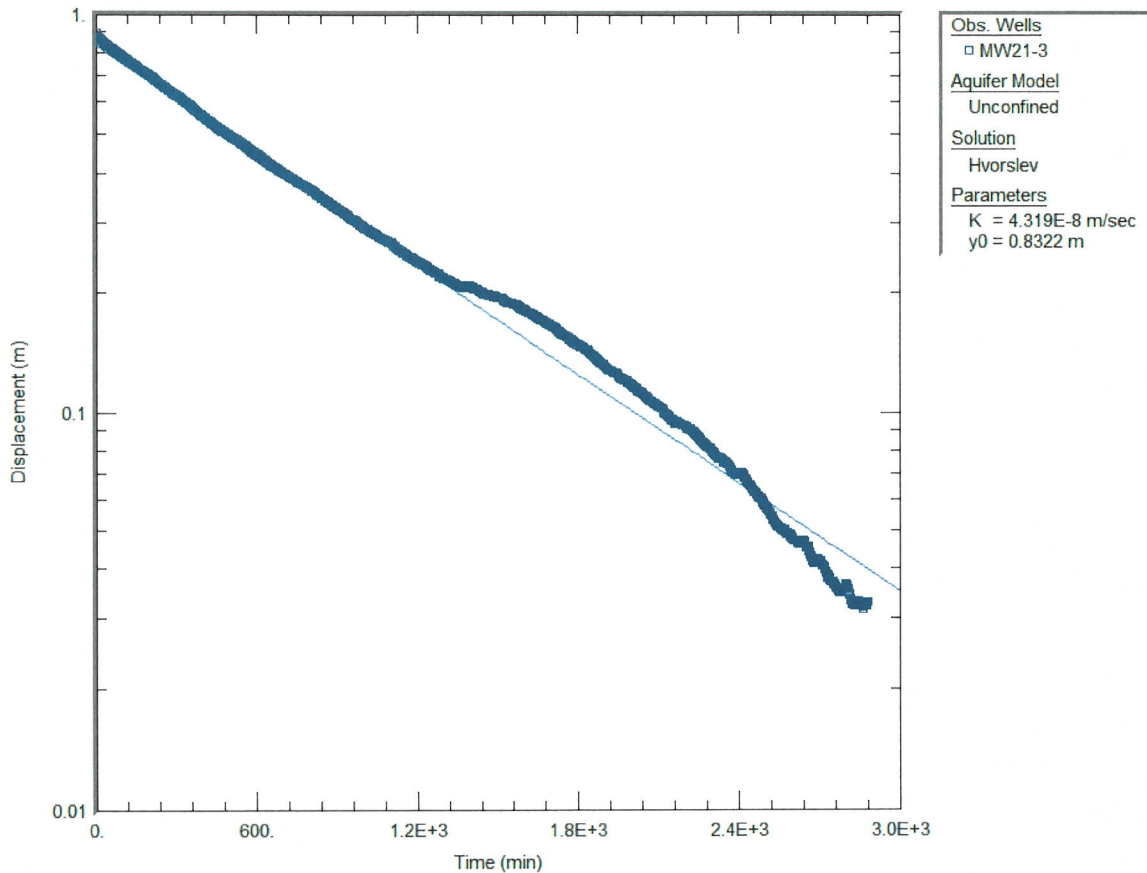
Figure 3. Hvorslev solution fit to slug test data from MW21-3

The hydraulic conductivity in MW21-3, completed within silty clay deposits, is 4.3×10^{-8} m/s. This is within the expected range for a silt clay deposits.

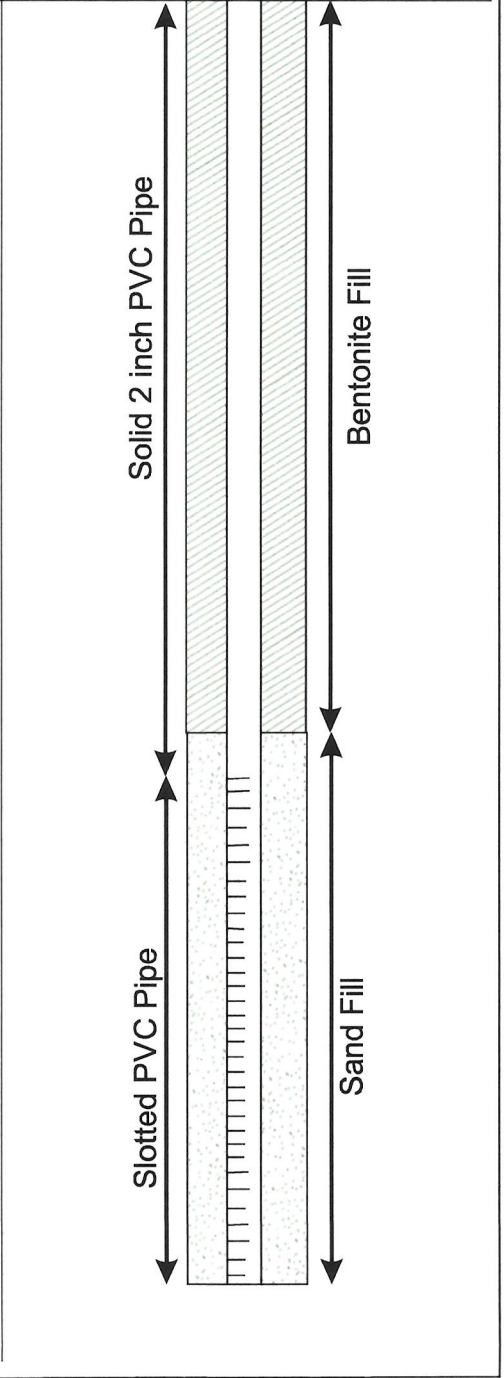
Topsoil - Black, under prairie grass

Silt - 10YR 5/4 Yellowish Brown - Loose, damp		
2

Silt Clay - Loose, medium plastic - 2.5Y 4/3 Olive Brown - Increasing clay content below 2.0 meters - Moist below 2.5 meters		
3

Silt Clay with Rare Gravel - Coal fragments, firm, moist - Mottled grey-brown		
8			Completed as Monitoring Well to 7.5 m

Silty clay deposits, of the same origin as encountered in the test pits, were encountered to a depth of 14.0 m. Sandstone bedrock was encountered from 14.0 – 16.5 meters below surface.

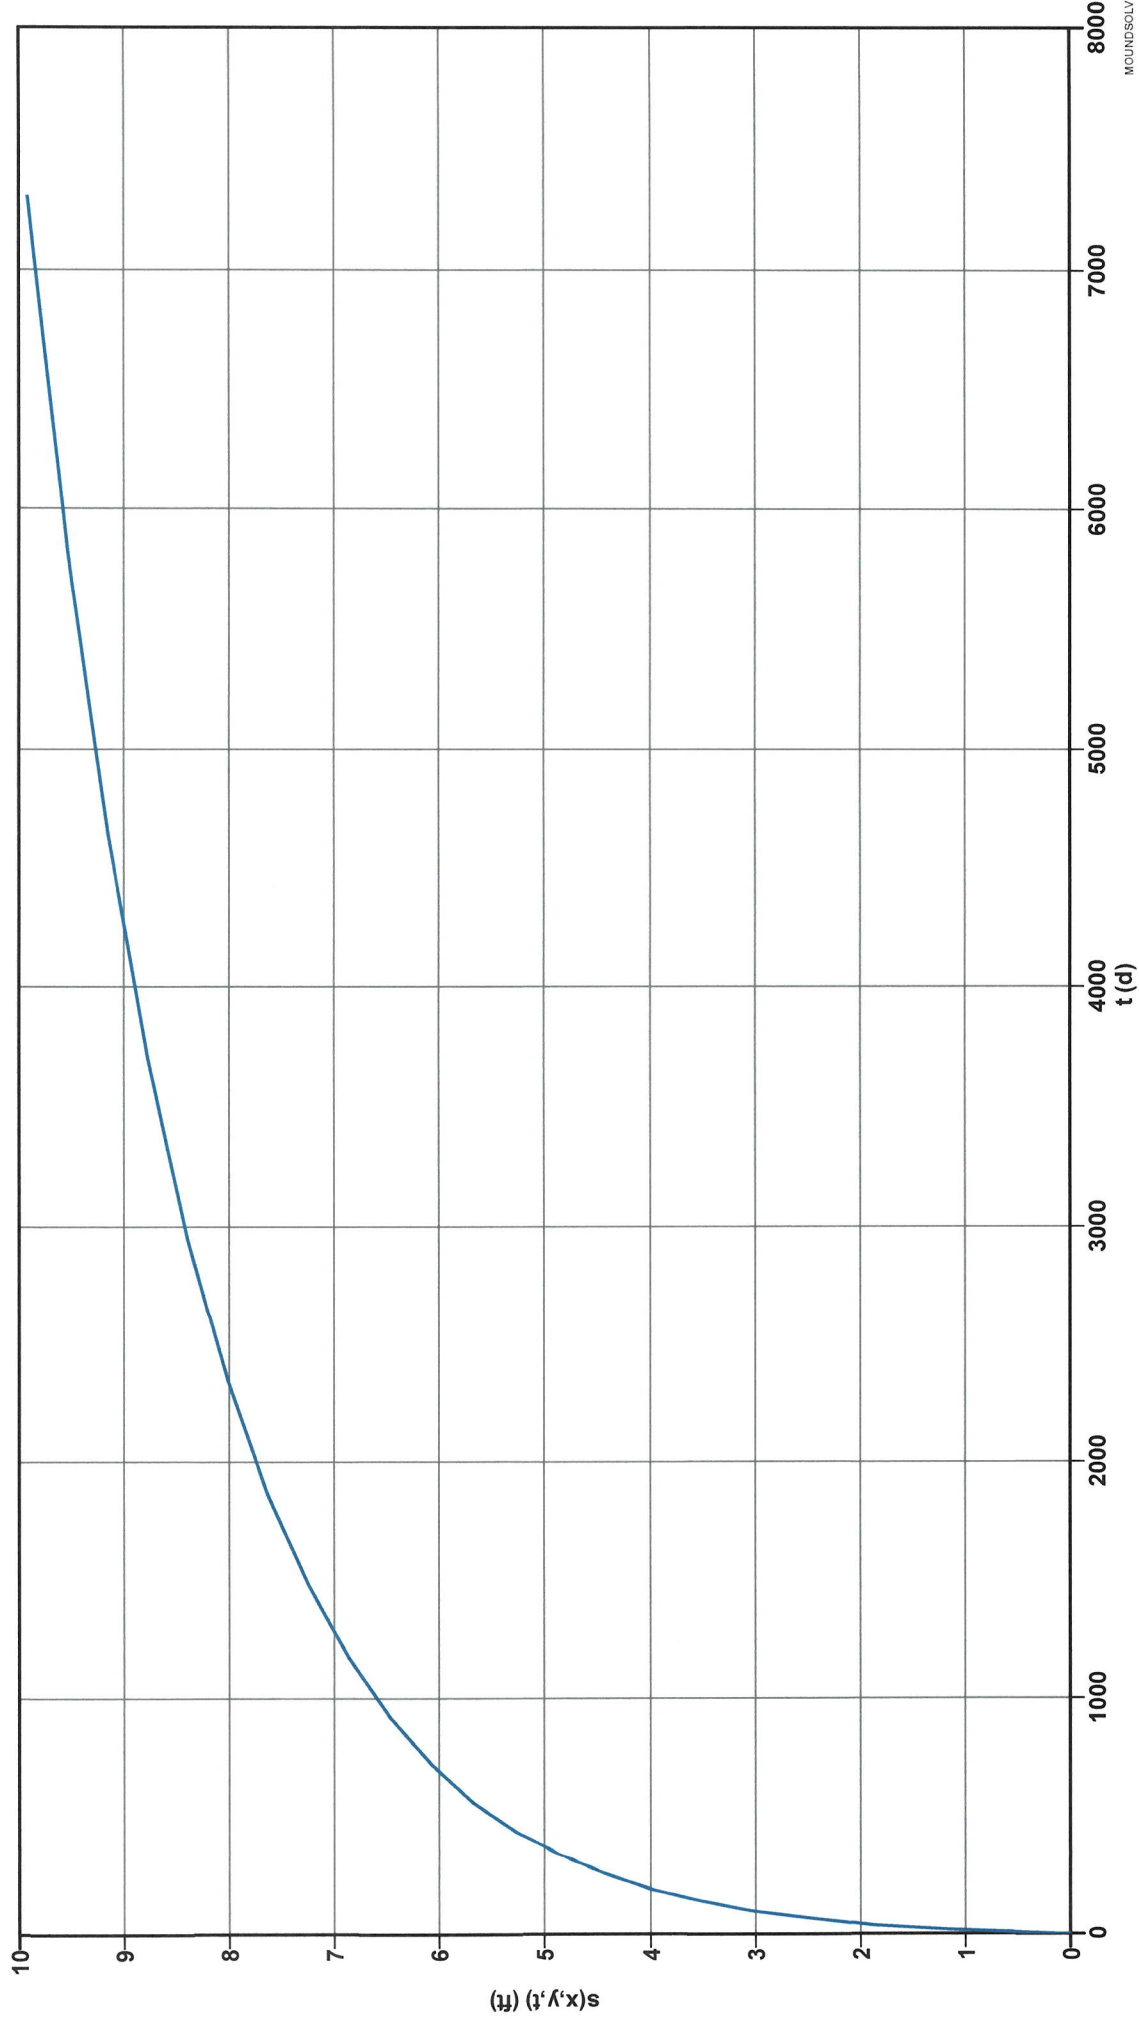
Water-Table Rise

Theoretical development of a mound underneath a septic field was modelled utilizing the Zlotnik Method and the MOUNDSOLV program developed by HydroSoft. Parameters used as input into the model include an infiltration rate of 1.5 m³/day, mound size of 6.8 m x 34.2 m and hydraulic conductivity values as determined from the field hydraulic conductivity tests. A storativity value of 0.2 was used for an unconfined aquifer (water table).

The results show a groundwater mound of 3.02 m will occur after 20 years. As the water table is on the order of 2 to 3 m a risk of breakthrough of septic field effluent could occur with conventional septic fields, and as was previously recommended, the sites should use a mounded system.

Mounding calculations show a risk with breakthrough of septic field effluent to the surface in sites underlain by shallow water table if a mounded treatment system is not installed. Thus, a mound system is recommended for all new lots developed on the site.
